Architectural Deterioration and Degradation of Cultural Heritage Typologies Along the Giráldez Avenue Thoroughfare in Huancayo

Adolfo Gustavo Concha Flores

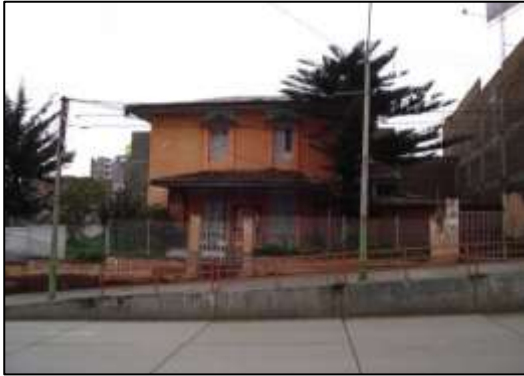
Figure 1

Architectural typology with monumental architectural value, which was in a clear process of deterioration and degradation, and as a result of the aggression of the economic dynamics of the real estate sector, concretized its destruction. (Mansion No. 500)

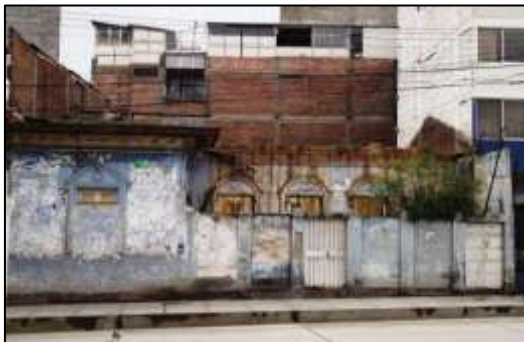
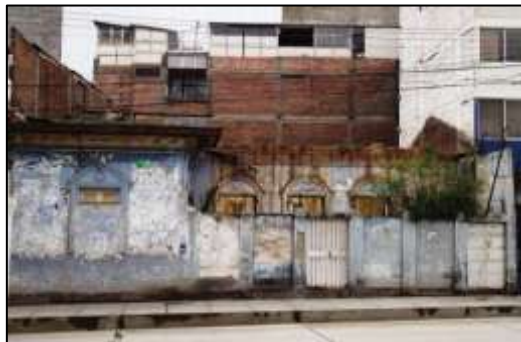
Figure 2

The impact of the dynamics of the investors have concretized the destruction of an architectural typology with monumental value, to which is added the negligence of the institutions and the population in general, and whose relevance was to express the language of the "U" House. (House No. 567)

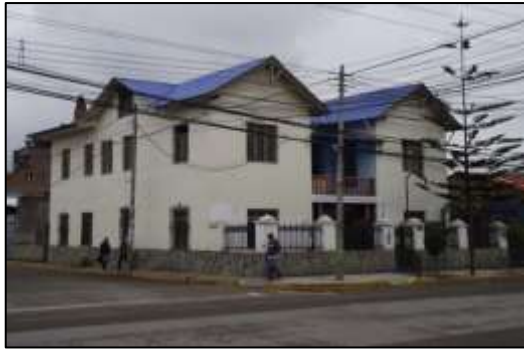
Figure 3

The expressions of monumental architectural valuation of this typology, with the language of the "U" House, so peculiar in the Mantaro Valley, determine its monumental value, and whose preservation corresponds to the interest of the owner or the real estate consultant. (Mansion No. 789)

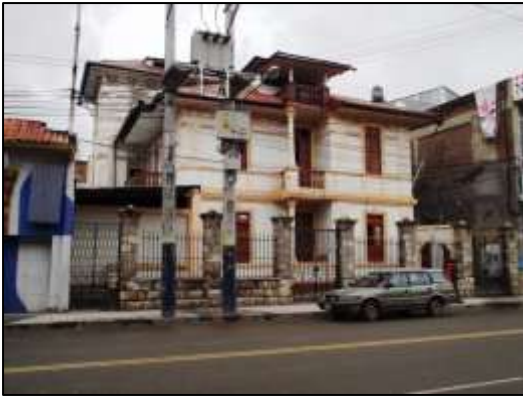
Figure 4

The language of this architectural work with monumental value was conceived under the dominant influence of the social and the economic, and whose formal relations determine that expression. The gold section is inherent in the relevance of its composition; (Mansion No. 201)

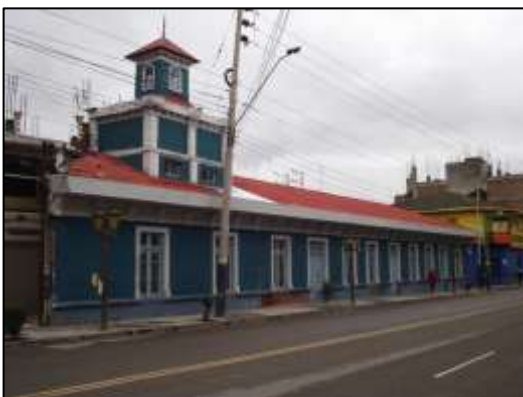
Figure 5

The peculiar expressions of this architectural typology offer a monumental value, which determines its valuation, and translate into an eminently political conception. Where formalist relations express the spatial hierarchy that it once showed. (Electro Centro Mansion)

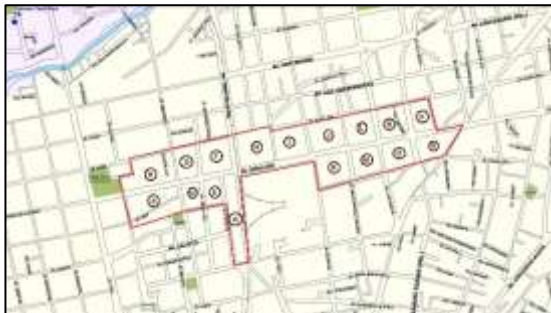
Figure 7

Delimitation of the study area, which is made up of 17 blocks and 45 architectural typologies of cultural heritage.

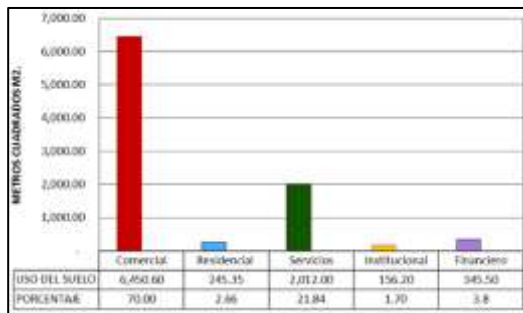
Figure 9: Land uses at the first levels.

Specific hypothesis: The deterioration and degradation of architectural land use in the first levels manifest a high level among the cultural heritage typologies in the road axis of Giráldez Avenue in Huancayo. The data in Table 3 and Figure 9 indicated that the land use habitat that is manifested in the first floors, obtained scores whose values of commercial land use, especially of a computer nature, determined a high level with 70% or 6,450 M2.; while for the use of land of services, especially computer services, it was 21.84% or 2,012 M2.; these data have allowed to describe the high level of interaction between the variables exposed and the confirmation that the land use that was manifested in the study area is mainly due to the urban function that this urban sector fulfills at the regional and even extra-regional level, which is to offer and demand computer products and services; on the contrary, a low level of interaction was observed in residential use, whose peculiarity is that they are homes of the guardians.

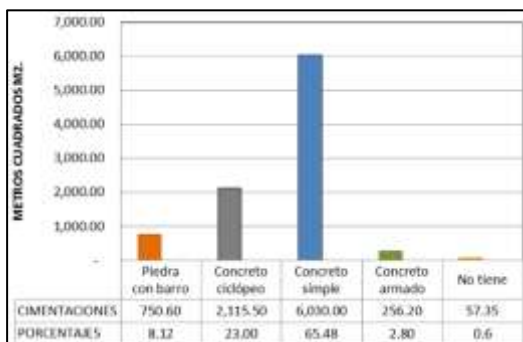
Figure 10: Construction technologies of foundations.

Specific hypothesis: The deterioration and degradation of the construction technologies of the foundations are manifested at a high level among the typologies of cultural heritage in the road axis of Giráldez Avenue in Huancayo. The data in Table 4 and Figure 10 indicated that the construction technology of the habitat that is manifested in the buildings under study, obtained scores whose values determined a high level with 65.48% or 6,030.00 M2.; for simple concrete foundations; followed by the use of cyclopean concrete foundations that concretized 23.00% or 2,115.50 M2.; These data allowed us to describe the high level of interaction between the exposed variables and the confirmation that the construction technologies of the foundations were used generically in the Cultural Heritage typologies, which determined the architectural monumental value in a preponderant way.

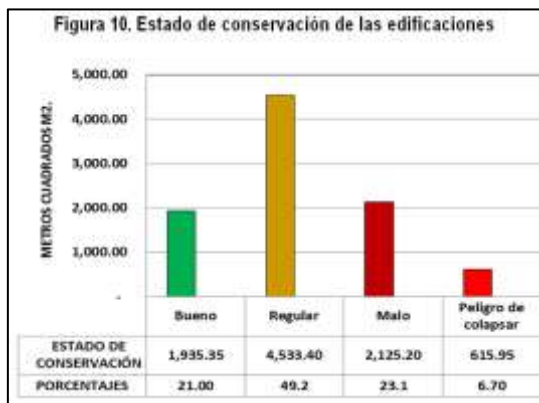
Figure 11: State of conservation of the buildings.

Specific hypothesis: The deterioration and degradation of the state of conservation are manifested at a high level among the typologies of cultural heritage in the road axis of Giráldez Avenue in Huancayo. The data in Table 5 and Figure 11 indicated that the state of conservation of the habitat that is manifested in the buildings under study, obtained scores whose values determined a high level with 49.20% or 4,533.40 M2. for buildings in a state of conservation of regular; followed by the state of conservation of bad that materialized 23.10% or 2,125.20 M2.; These data allowed us to describe the high level of interaction between the exposed variables and the confirmation that the state of conservation of the buildings in their first levels have a tendency towards a non-optimal conservation of their construction systems, which determine that the architectural monumental heritage is in danger of conservation.

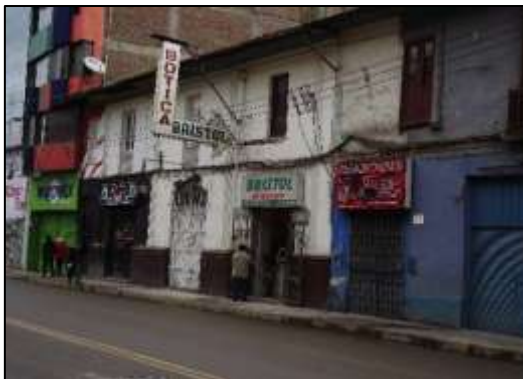
The alteration of land uses; The study area has undergone a dynamic process of alterations in its formal expressions due to the new land uses, the result of which was the decrease in residential use at the first levels generated by the pressures of tertiary activities, especially commercial, financial and service uses, due to the urban function it fulfills at the city level. region and even at the national level, which has concretized its deterioration and degradation as a monumental architectural heritage.

Figure 6: The change of use to which this monumental typology is subjected is evident; determined a process of deterioration and degradation in its formal expression. (Mansion No. 258)

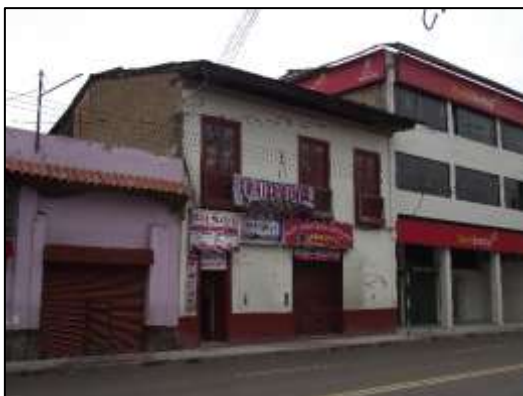
Physical deterioration of its buildings; Traditional construction technologies are being replaced by contemporary technologies such as reinforced concrete and the use of earth-fired clay brick or concrete, which has produced anomalous and dissimilar scenographic proposals to the context of this area, which contradictorily is deteriorating the monumental urban image and its spatial structure, and whose cause is mainly due to the new tertiary activities that act at the city level. regional and extra-regional.

Figure 7: The change of use to which this urban framework is subjected is evident; which have determined a process of deterioration and degradation in their formal expression of

this context, due to the insertion of alien typologies. (ScotiaBank Case No. 216 and Chifa Wang No. 208)

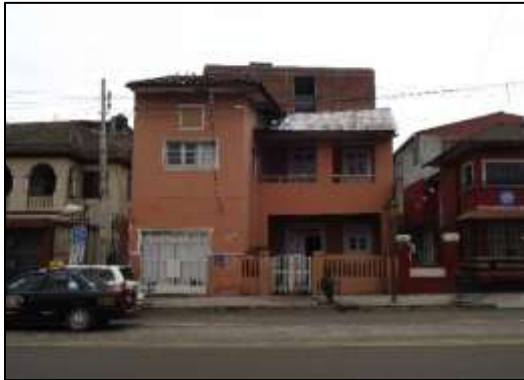
Alterations of the aesthetic-formal structures of architectural typologies; the insertion of architectural typologies with formal aesthetic peculiarities of uneven and hybrid character in the time of production, due to the cultural penetration and influence of architectural patterns, which has contradictory modified the contextual structure of the monumental area, due to the growing and complex urban role it fulfills.

Figure 6: The insertion of contemporary architectural typologies damaged the urban image in this sector, in the formal aspect. (Mansion No. 789)

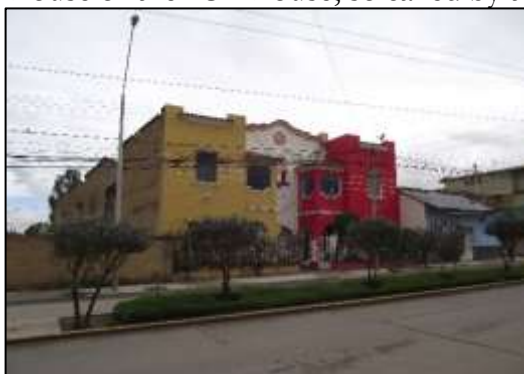
Classic "U" shaped typology. (Mansion No. 789)

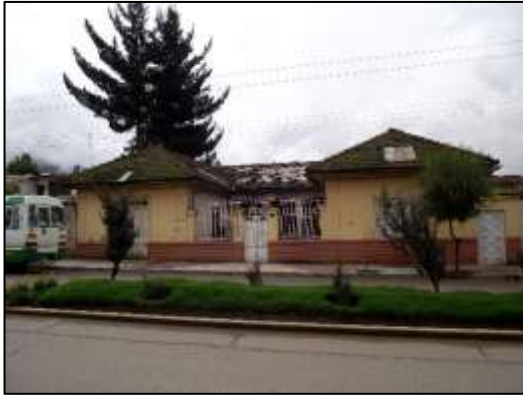
Another typology in the shape of a "U". (Mansion No. 789)

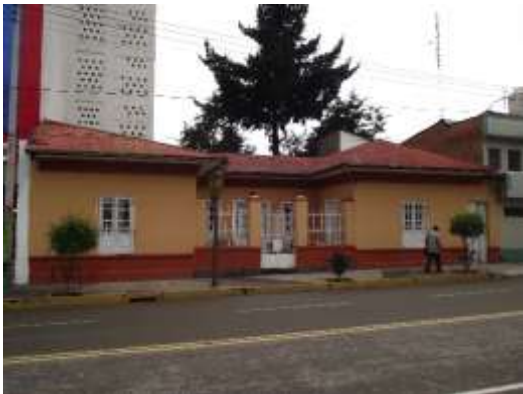
The classic "U" shape, in good condition. (Mansion No. 789)

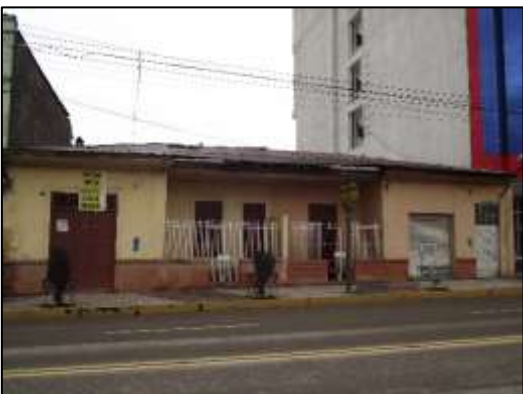
And others are in the process of deterioration and degradation, as a result of the real estate maelstrom.

U-shaped typology in a state of deterioration (No. 789)
